**1964-66**

**CONVERTIBLE TOP  
REPAIR MANUAL**

**MUSTANG — FALCON — COMET  
FORD — MERCURY**

# SERVICING CONVERTIBLE TOPS

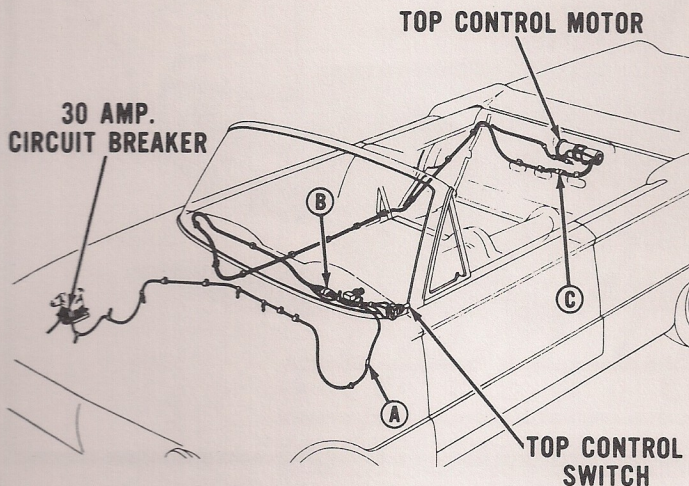
Figure 1—Convertible Top Electrical System

The conventional convertible top electrical system uses an electric motor, a control switch, a circuit breaker and the necessary wiring to complete the circuit as shown in the illustration (Fig. 1).

A 12-volt motor is used to drive a hydraulic pump. The motor is reversible so that the pump can be driven in either a clockwise or a counterclockwise direction. The motor and pump assembly is mounted behind the rear seat back. The top switch is mounted in the instrument panel.

1. Connect one test lamp lead to the black (feed) wire of the top control switch, connect the other lead to a good ground (Fig. 3). The illustration, Fig. 1, shows the approximate location of the top control switch. If the test lamp lights there is power at the switch. If the test lamp fails to light, there is an open or short circuit between the battery and the switch.

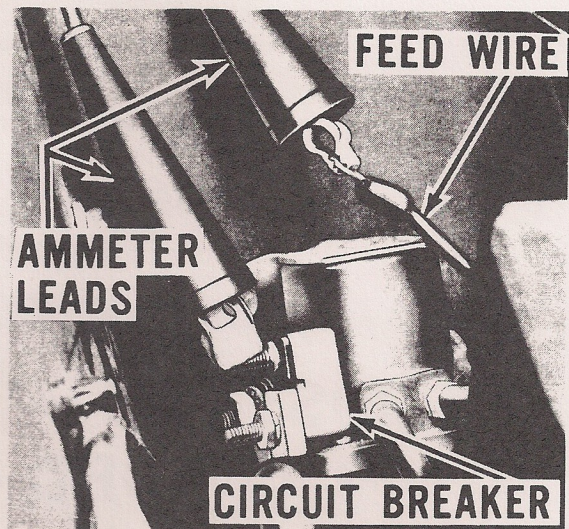
Figure 2—Current Draw Check

To check the current draw in the top operating circuit, disconnect the black wire at the circuit breaker (located on the starter relay), and connect an ammeter in series in the circuit (Fig. 2).

Operate the top control switch and note ammeter reading. The current draw should be 20 to 40 amperes for Ford and Mercury; 25 to 30 amperes for Falcon, Mustang and Comet; and 40 to 50 amperes stalled, with a reading of 9-10 volts.

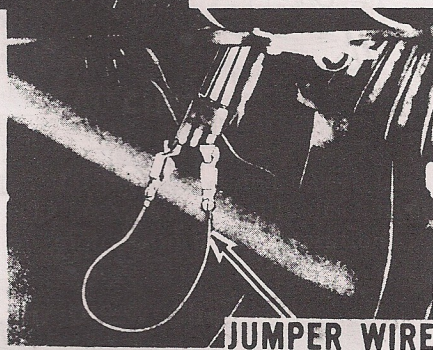
Figure 4—Jumper Wire For Switch Wiring

2. If there is power to the switch, connect a jumper wire between the black (feed) wire and the red wire, and then between the black and the yellow wire (Fig. 4). If the top motor operates, the switch is faulty and must be replaced.

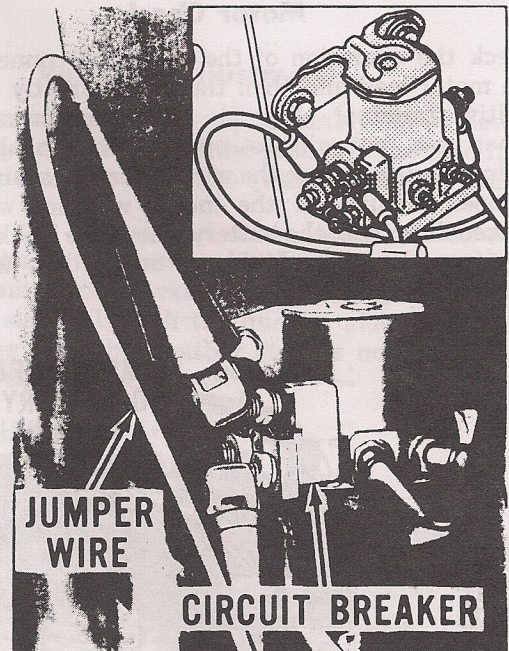
Figure 5—Circuit Breaker Test

If there is no voltage at the top control switch, connect a jump wire across the terminal of the circuit breaker (located on the starter relay, Fig. 5) and operate the switch. If the top motor operates the circuit breaker is faulty and must be replaced.

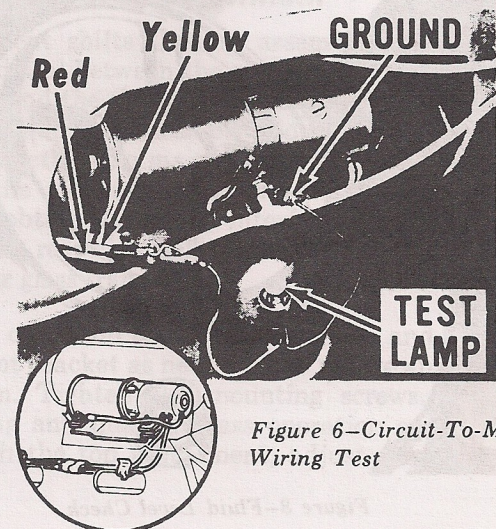
Figure 6—Circuit-To-Motor Wiring Test

Disconnect the yellow and red switch-to-motor leads at the junction block near the motor. Connect a test lamp between the yellow wire and a good ground (Fig. 6). Operate the top control switch. If the lamp lights there is current to the junction block.

Connect the test lamp between the red wire and a ground, and check by operating a switch. If the test lamp does not light, the wire from the junction block to the switch is defective.

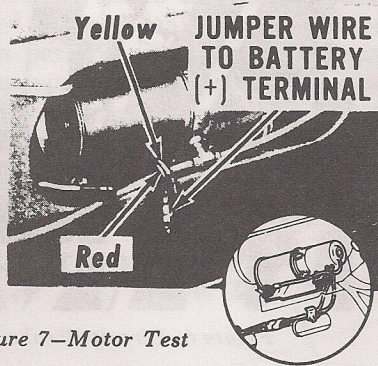
Figure 7—Motor Test

Check the operation of the motor by connecting first one motor lead and then the other directly to battery positive terminal (Fig. 7). If the motor operates in either case, but will not operate when hooked to the wiring harness, check the wiring harness again for short or open circuits. If the motor will not work when hooked directly to the battery, check the black (ground) wire from the motor. If the motor still does not operate, it must be replaced.

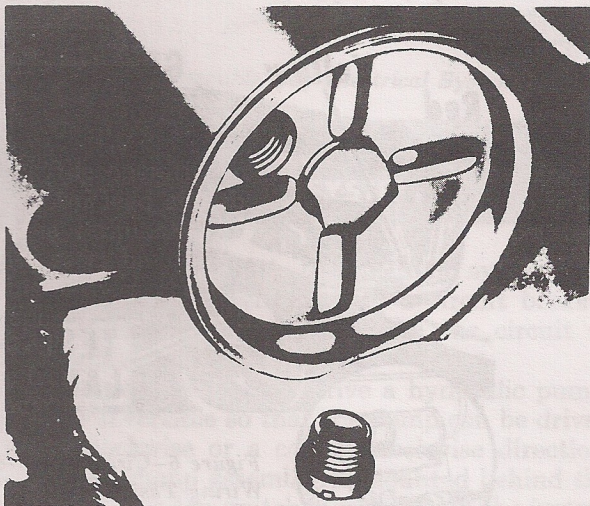
Figure 8—Fluid Level Check

To check the fluid level, raise the top and remove the rear seat cushion and seat back. Place absorbent cloths below the filler plug to absorb any spillage of hydraulic fluid. Remove the filler plug and check the fluid level (Fig. 8). It should be level with the bottom edge of the hole. Do not attempt to operate the top with the filler plug removed. If the level is low check the system for leaks, then add the required amount of fluid and replace the filler plug.

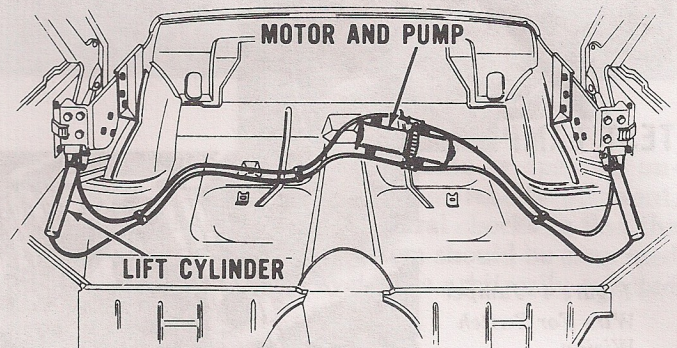
Figure 9—Lift Cylinder Check

Remove the rear seat cushion, seat back and quarter trim panels. Operate the top control switch, and observe the operation of the lift cylinders. If the movement of the piston rods is sluggish or uneven, check the lines from the pump to the cylinders for kinks or obstructions (Fig. 9). If one piston rod moves more slowly than the other, the cylinder with the slower rod is defective and should be replaced. If both rods move slowly, or do not move at all, and the motor and pump are operating, the pump is defective and should be disassembled and repaired.

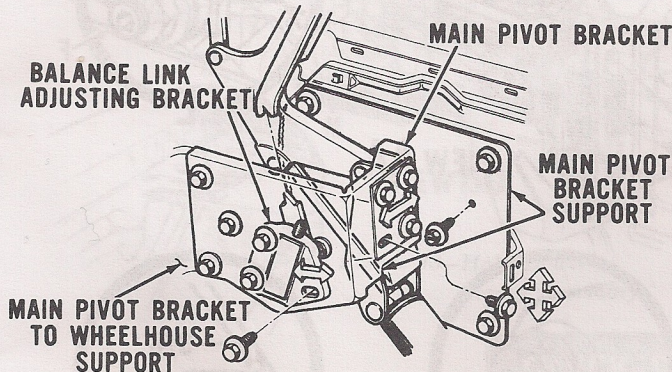
Figure 10—Linkage Adjustments

The balance link adjusting bracket is mounted on the main pivot bracket support (Fig. 10). Two adjustments are provided at the bracket. Sliding the bracket in the elongated mounting holes permits proper stacking of the top in the well. Turning the Allen head adjusting screw in the bracket corrects sag in the side rails.

The main pivot bracket is mounted on the main pivot bracket support (Fig. 10). The support is mounted to the inner quarter panel and the wheelhouse extension. The main pivot bracket and its support provide for the shifting of the entire top assembly, fore and aft, vertically and laterally. Because the movement of the main pivot bracket will disturb several adjustments, move this bracket only after other adjustments have failed to solve a specific problem.

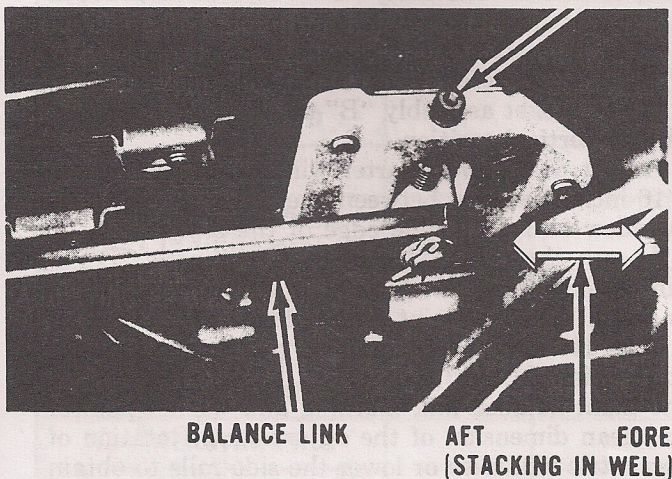
Figure 11A—Balance Link Adjustment

To lower the top stack in the well, loosen the balance link adjusting bracket mounting screws, and slide the bracket forward (Fig. 11A). To raise the top stack in the well, loosen the balance link adjusting bracket mounting screws, and slide the bracket rearward.

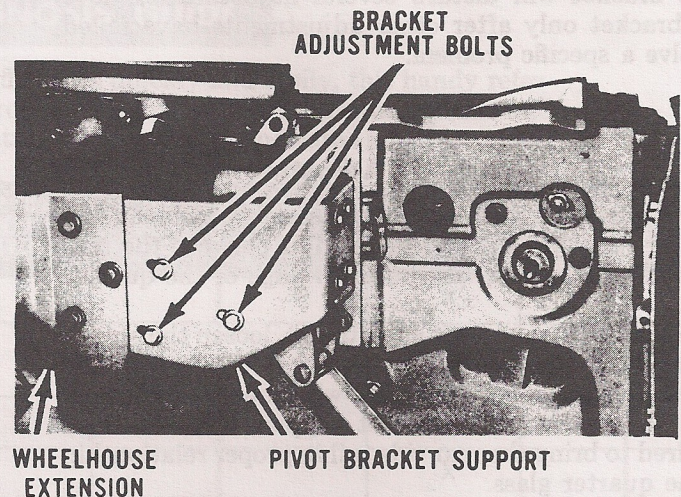
Figure 11B—Bracket Adjustments

If the side rail sags above the door glass, raise the top and lock it in full up position. Using the top and quarter glass as reference points, determine the proper level of the side rail. With an Allen wrench turn the adjusting screw in the balance link adjusting bracket down to raise the side rail to the proper level (Fig. 11B).

To adjust the top up and down loosen the screws that retain the main pivot bracket support (Fig. 11-B). Shift the main pivot bracket up or down as necessary to level the side rails with the quarter glass and door glass. Making sure the weather strip is not bottomed on the glass, tighten the screws.

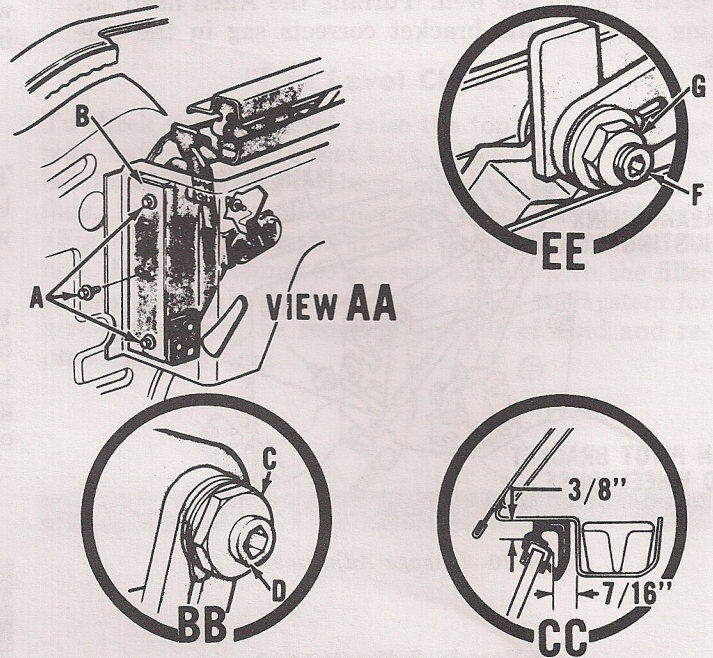
Figure 12—Folding Top Adjustment

The side rail weatherstrips can be adjusted laterally and also fore and aft (Fig. 12). Lateral adjustment of the weatherstrip is necessary to assure full contact between the sealing lips and the door and quarter window frames.

Fore-and-aft adjustment of the weatherstrip is necessary to butt the ends of the weatherstrip together to provide a watertight seal. At times it may be necessary to trim the ends of the weatherstrip to prevent bulges at the joints which may prevent proper sealing.

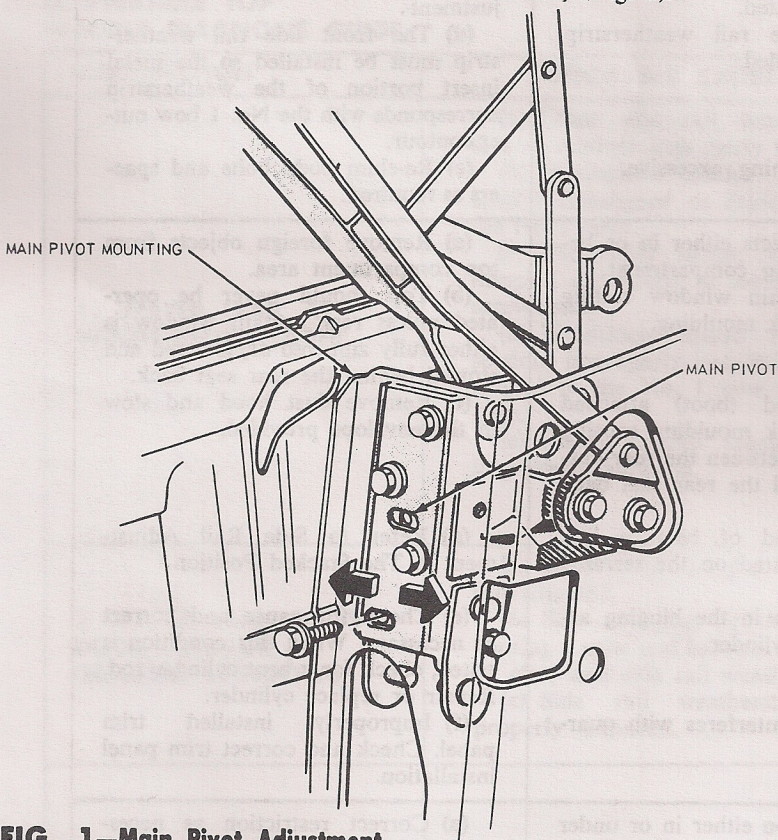
**FIG. 1—Main Pivot Adjustment**

1. Clamp the No. 1 bow to the windshield header.
2. Loosen the main pivot mounting attaching bolts on one side of the body (Fig. 1).

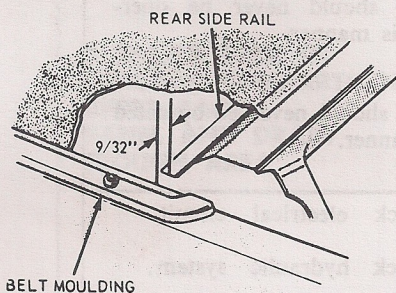
**FIG. 2—Top Side Rail-To-Body Clearance**

3. Move the main pivot mounting side to side as necessary to obtain a  $\frac{9}{32}$ -inch clearance between the outer edge of the rear side rail and the inner flange of the quarter belt moulding (Fig. 2).

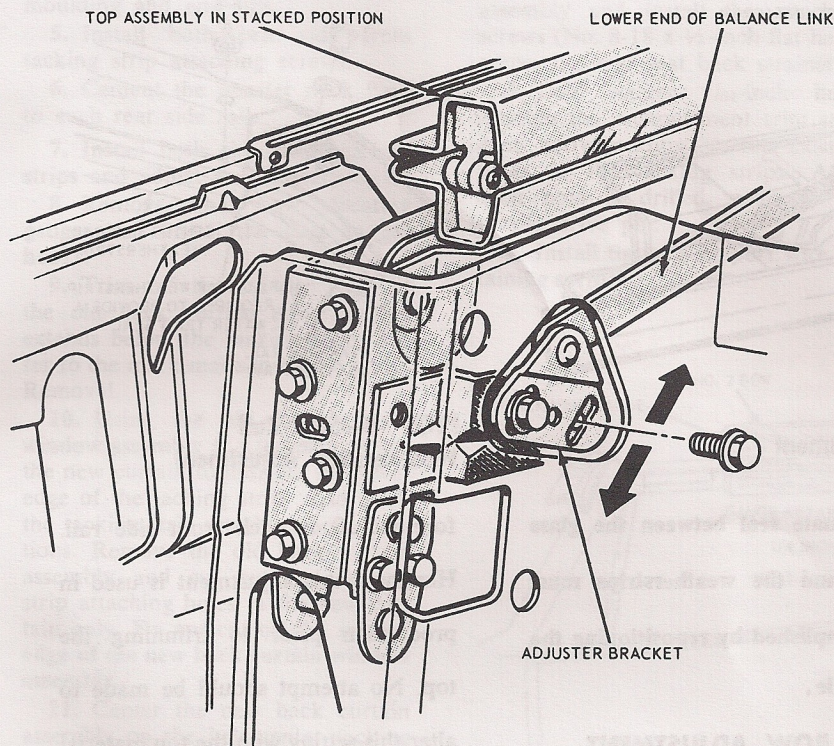
**FIG. 3—Side Rail Stacked Height Adjustment**

The balance link lower attaching plate is adjustable to permit maximum lowering of the side rail in the stacked position (Fig. 3).

Loosen the adjuster bracket retaining bolts (Fig. 3) and move the bracket as necessary to lower the stacking height. Then, tighten the adjuster bracket retaining bolts.

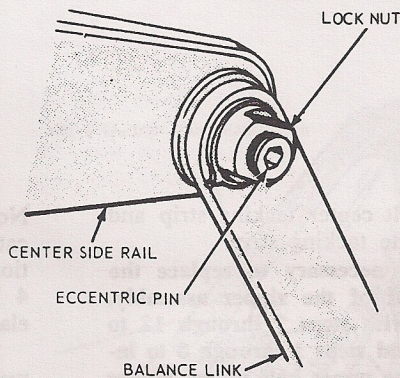
**FIG. 4—Balance Link Eccentric Adjustment**

The balance link upper attachment incorporates an eccentric to obtain the required seal between the side rail weatherstrip and door glass (Fig. 4).

1. With the top in the raised position, loosen the eccentric lock nut (Fig. 4) and rotate the eccentric pin to obtain a  $\frac{3}{8}$ -inch clearance between the door glass frame and the front and center side rails (Fig. 5). This dimension increases  $\frac{9}{16}$ -inch along the quarter window radius.

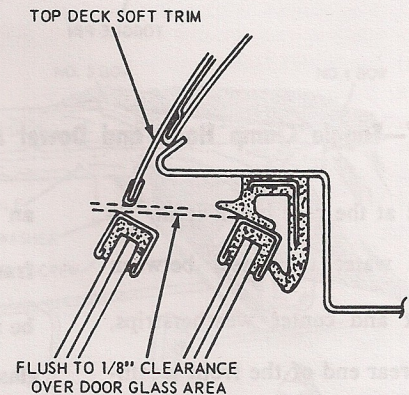
**FIG. 6—Top Material to Door Window Clearance**

The No. 2 bow to side rail attaching bracket also incorporates an elongated vertical slot to permit up and down adjustment of the bow to obtain the specified clearance between the top edge material and the door window line (Fig. 6).

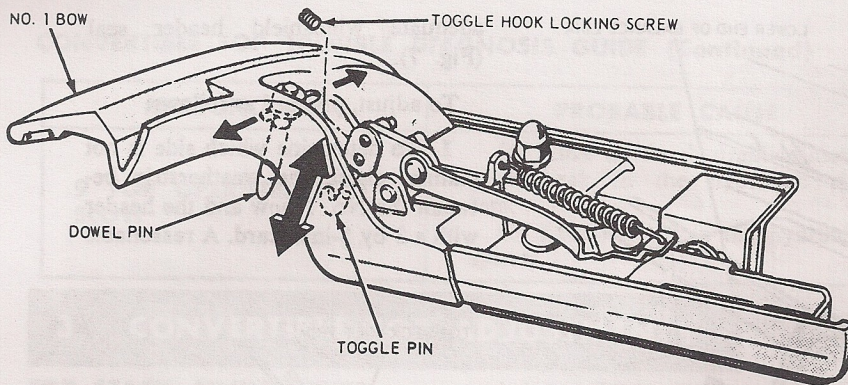
**FIG. 7—Toggle Clamp Hook and Dowel Adjustment**

2. Release the toggle clamps, loosen the locking screw (Fig. 7), and thread the toggle hook in or out until adequate sealing pressure is applied at the header weatherstrip. Tighten the toggle clamp locking screw after adjustment. Excessive tightening is detrimental to a good seal.

3. The No. 1 bow dowel pins are adjustable inboard and outboard to obtain proper relationship of the No. 1 bow to the windshield header (Fig. 7). Loosen the dowel pin lock nut and adjust the dowel pin inboard or outboard as necessary (Fig. 7). Tighten the lock nut.

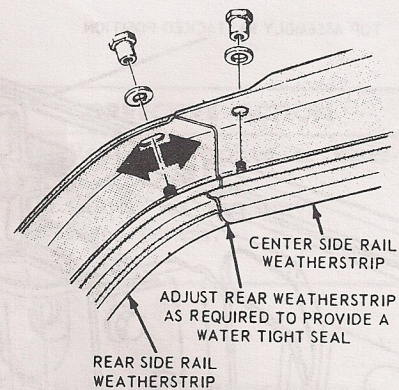
**FIG. 8—Side Rail Weatherstrip Adjustment**

The center and rear side rail weatherstrips are adjustable fore-and-aft to obtain an interference fit between weatherstrip sections (Fig. 8).

The center and rear side rail weatherstrips are adjustable fore-and-aft (Fig. 8) to provide a water

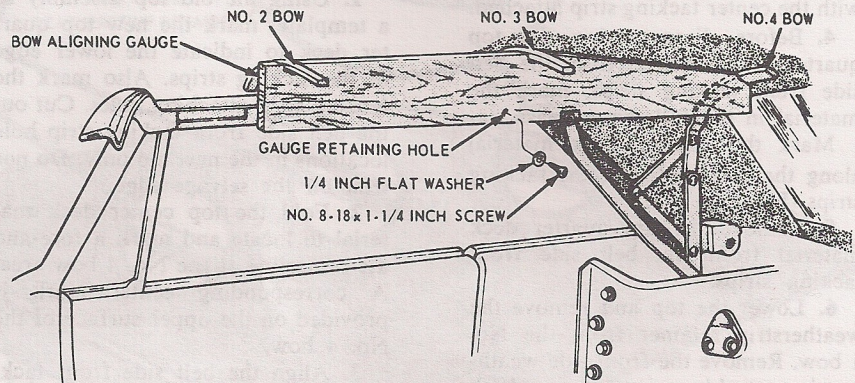
FIG. 10—Bow Locating Gauge Installation

8. Remove both side rail coat hanger hooks and install the two fabricated bow alignment gauges (Figs. 9 and 10). Retain each gauge with a No. 8-18 x 1 1/4-inch pan-head screw and washer (Fig. 10).

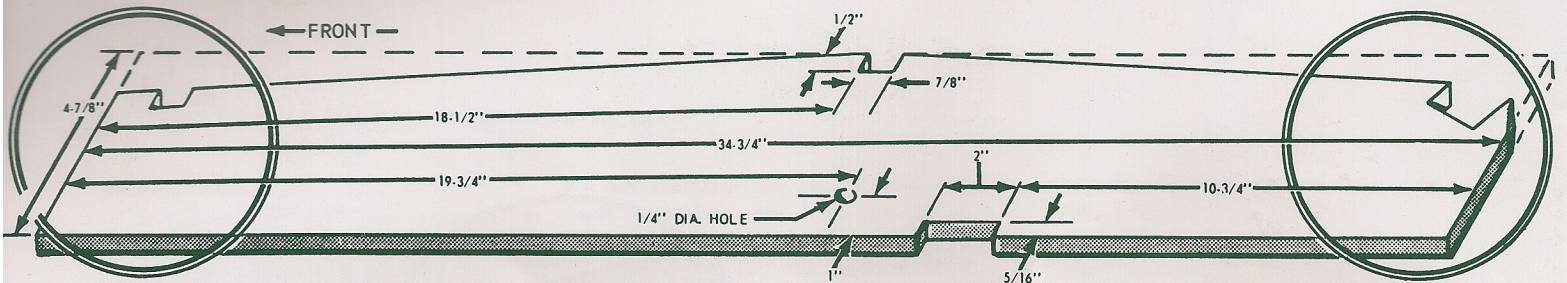
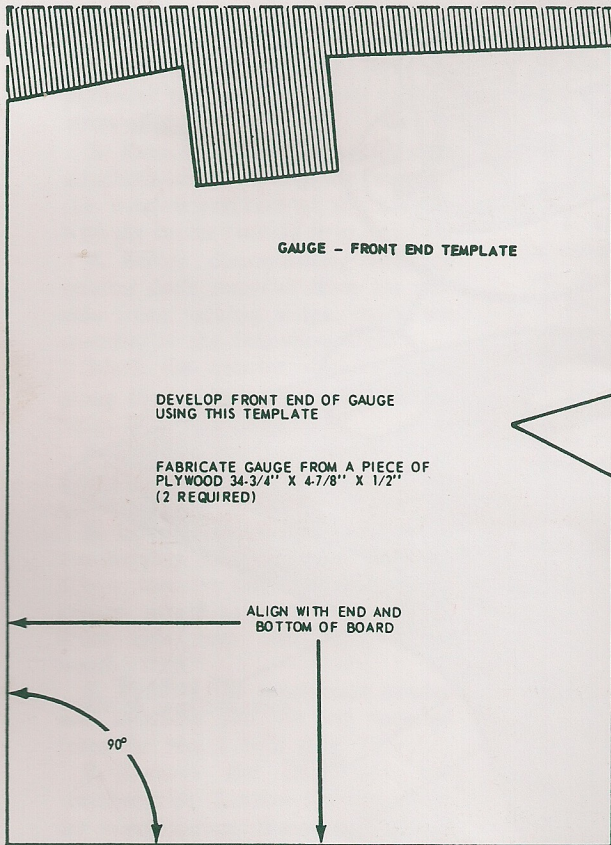
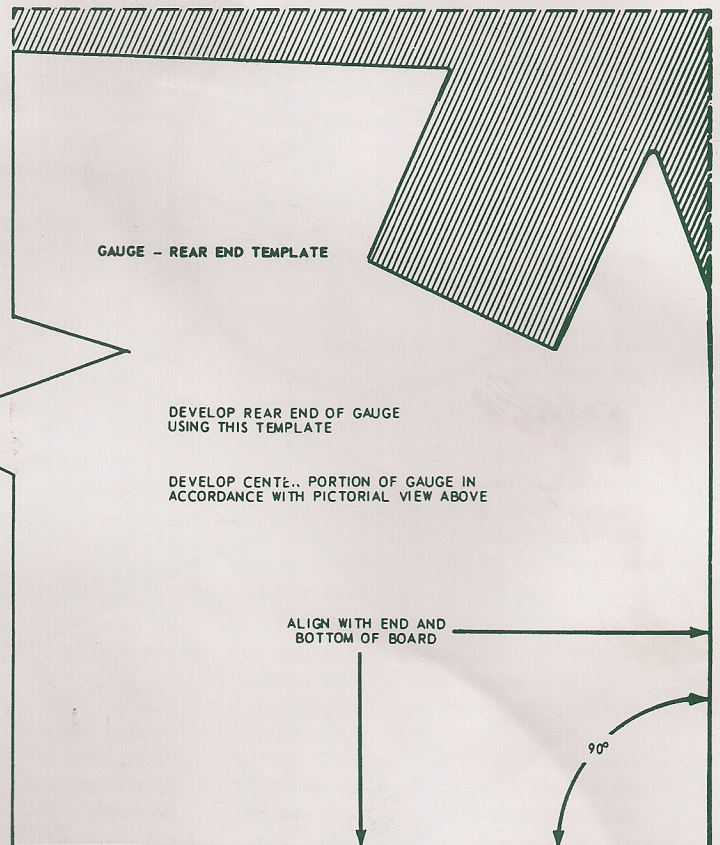
FIG. 9—Bow Locating Gauge

Fabricate two bow locating gauges to the dimensions illustrated in Fig. 9.
